UNDERWATER BRIDGE INSPECTION REPORT

STRUCTURE NO. 31516
TWP NO. 273
OVER THE
MISSISSIPPI RIVER
DISTRICT 1 - ITASCA COUNTY

PREPARED FOR THE
MINNESOTA DEPARTMENT OF TRANSPORTATION
BY
COLLINS ENGINEERS, INC.
JOB NO. 3512 (CEI 8A)

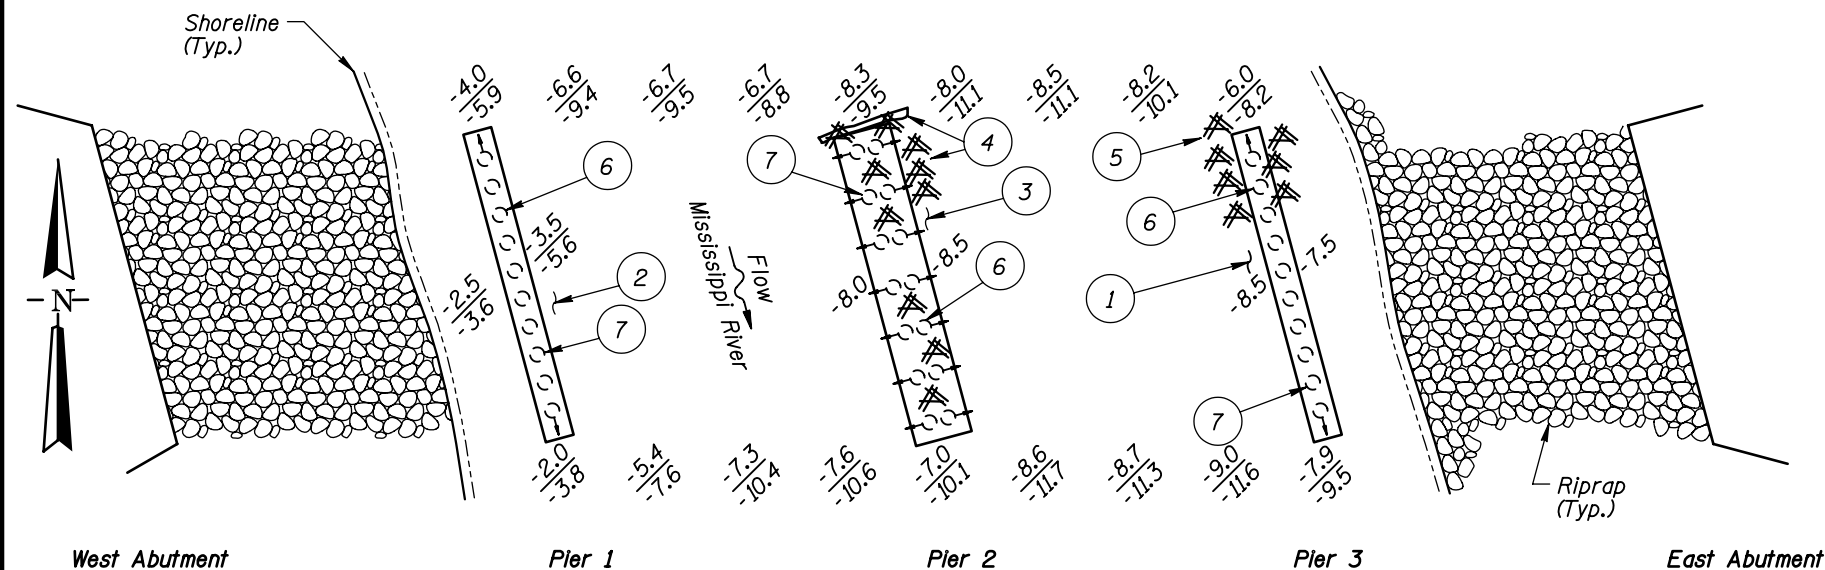
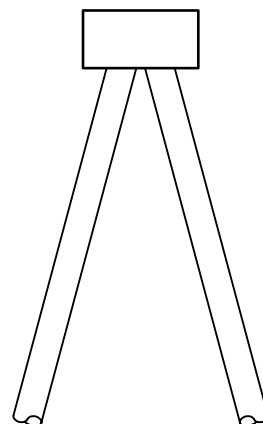
INSPECTION AND SOUNDING PLAN

- 1 The channel bottom material consisted of firm sandy gravel with cobbles and 1 foot diameter riprap and 2 to 3 inches of probe rod penetration.
- 2 The channel bottom material consisted of silty sand with cobbles and scattered riprap.

- 3 The channel bottom consisted of silty sand with up to 1 foot of probe rod penetration.
- 4 Moderate accumulation of up to 1 foot diameter timber debris from the channel bottom to 3 feet above the channel bottom scattered around the upstream piles and extending along the east upstream side of the pier with a 1 foot diameter log located across the upstream piles at the waterline.

- 5 Light accumulation of timber debris from the mudline to 2 feet above the channel bottom around upstream piles.
- 6 Minor scour pockets, 1 to 2 feet deep with 1 to 2 feet radius, were observed at all piles.

- 7 Steel pipe piles exhibited 100% coating failure from 3 feet above the waterline to the channel bottom with 50 to 100% coverage of typically 1/4 to 1/2 inch diameter rust nodules and up to 1 1/2 inch diameter rust nodules from 3 feet below the waterline to the channel bottom of Piers 2 and 3. There was minimal loss of section with pitting that was typically 1/32 inch to maximum 1/16 inch deep.

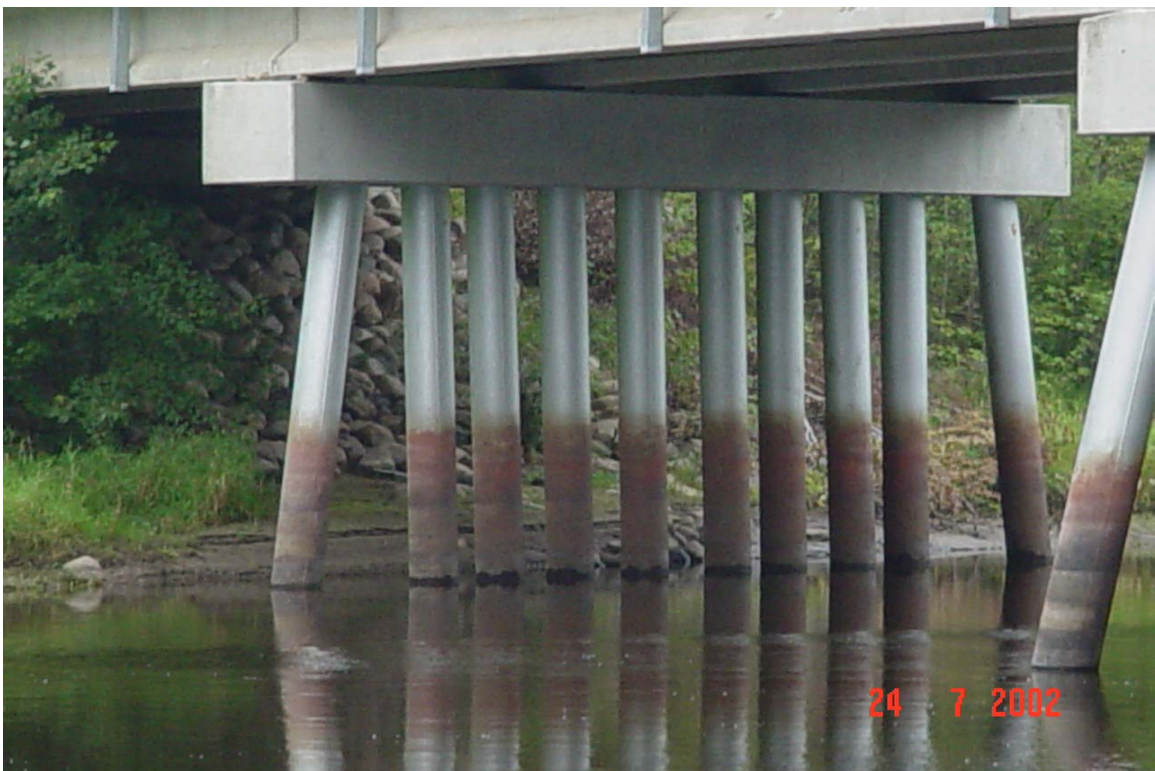
Photograph 2. View of Pier 1, Looking Northwest.

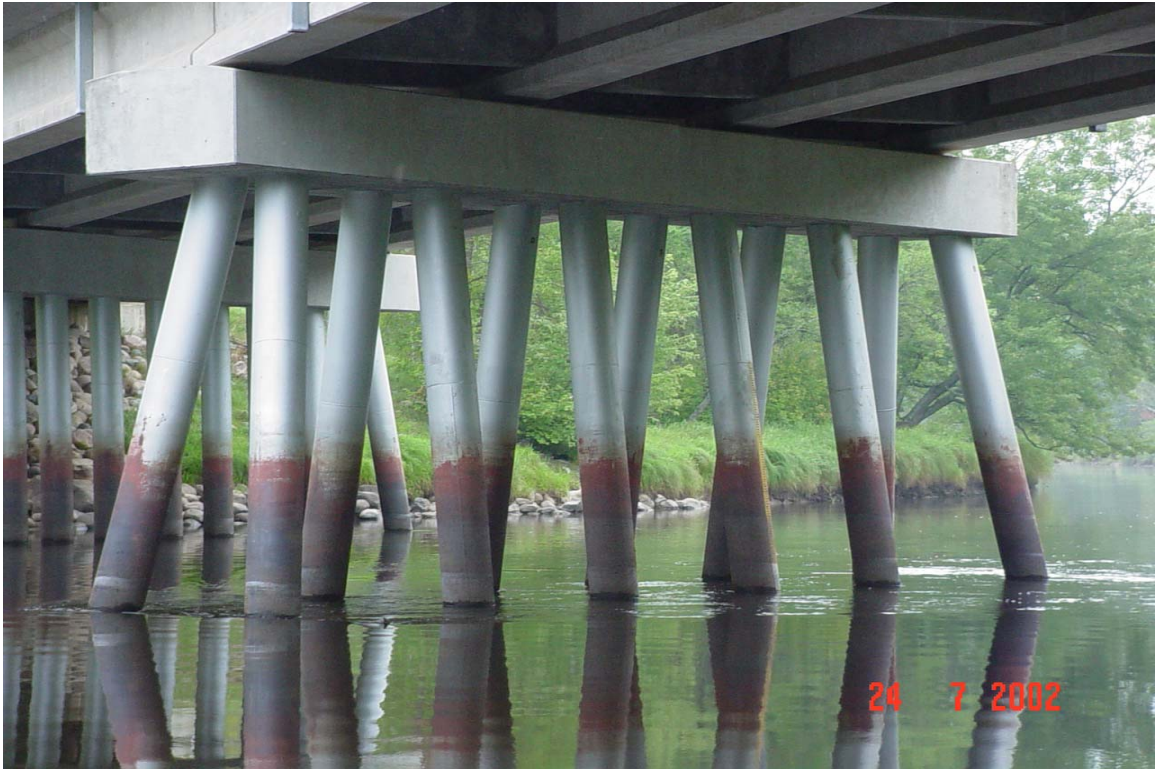
Photograph 3. View of Pier 2, Looking Southeast.

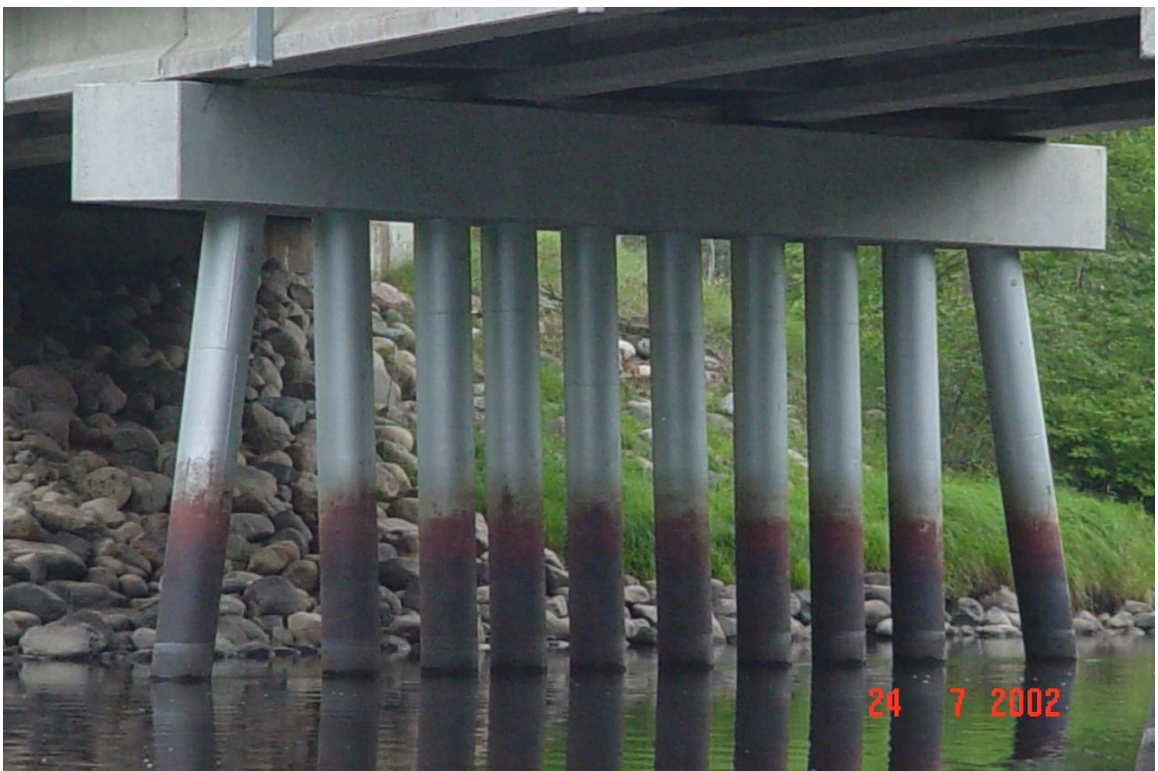
Photograph 4. View of Pier 3, Looking Southeast.
